**MONOTONIC AND FATIGUE LOADING
BEHAVIOR OF AN OXIDE/OXIDE
CERAMIC MATRIX COMPOSITE**

THESIS

Steven G. Steel, Captain, USAF

AFIT/GMS/ENY/00M-02

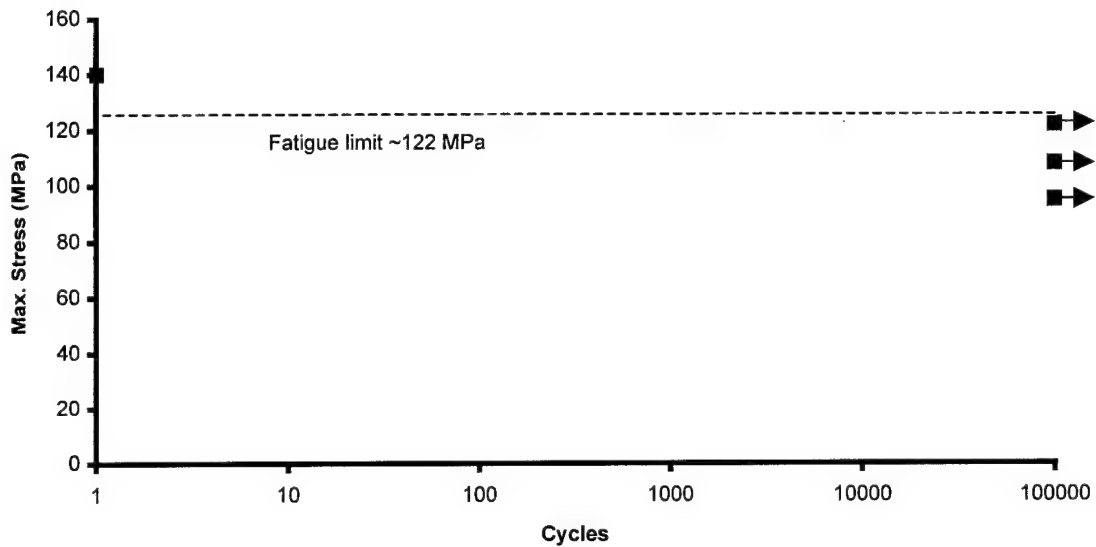
Figure 4-30 1200°C S-N curve for N720/A

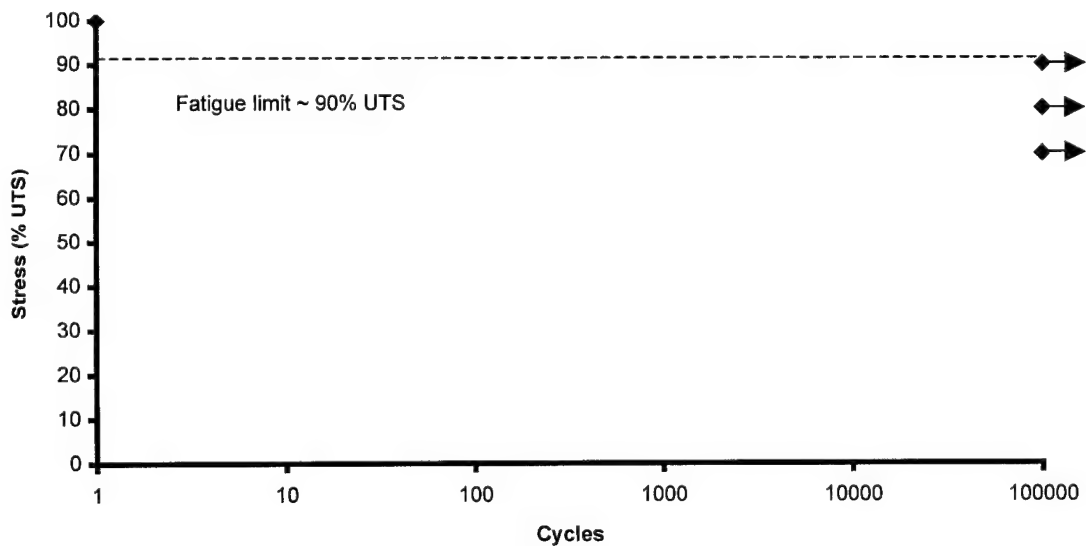
Figure 4-31 Normalized 1200°C S-N curve for N720/A

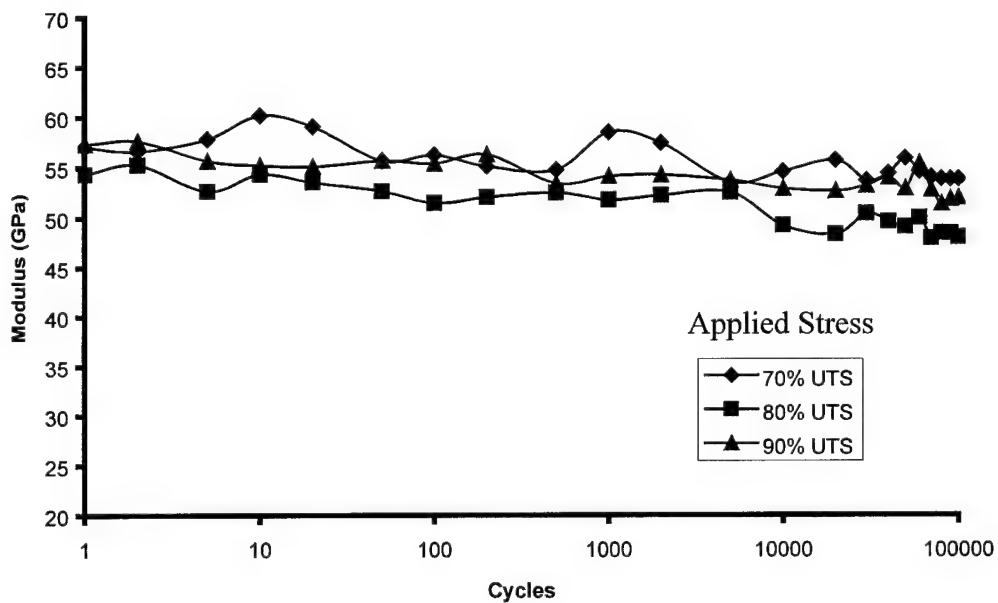
bumps in the data are likely caused by thermal currents from the furnace. The thermal currents cause small fluctuations in the extension measured by the extensometer. Most of the extension measured at 1200°C is actually due to the specimen being stressed, but a small part is the expansion and contraction of the specimen due to thermal currents.

Figure 4-32 Modulus degradation in 1200°C fatigue testing

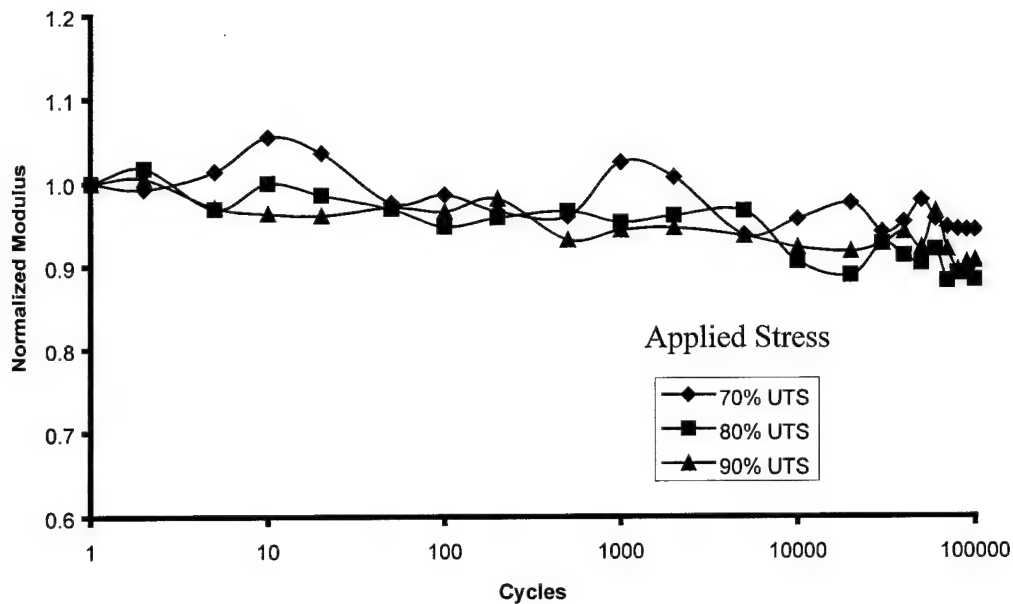
Figure 4-33 Normalized modulus trends in 1200°C fatigue testing

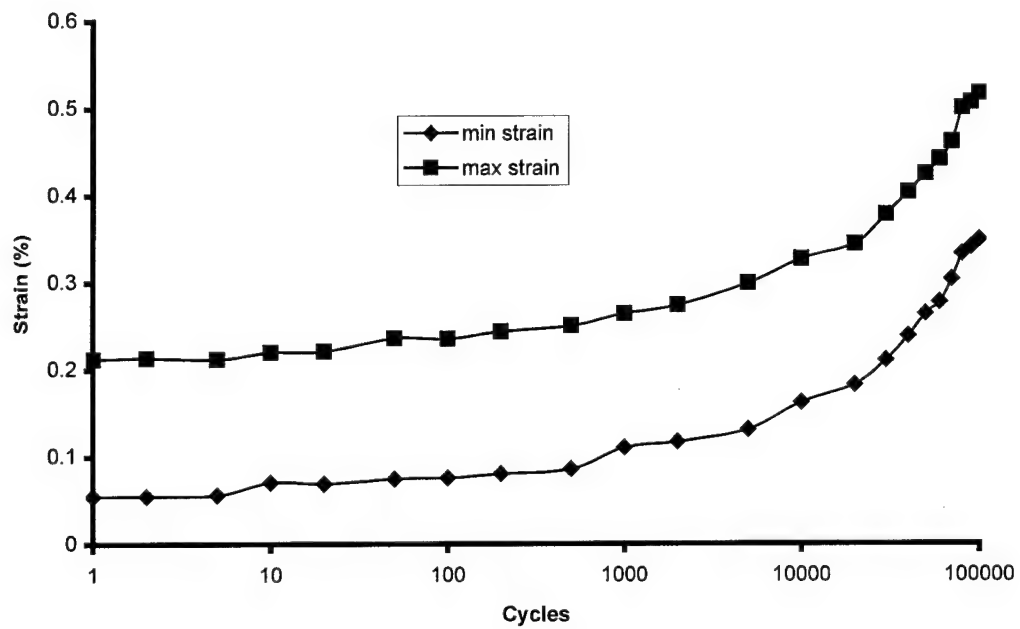
Strain data is the next indicator of damage during fatigue. The next three figures show maximum strain and minimum strain vs. number of stress cycles for each of the three high temperature fatigue tests (at 70, 80 and 90% stress levels). These graphs are very different from the room temperature graphs. At room temperature the minimum strain stayed about the same while the maximum strain drifted higher due to the decrease in composite modulus. There was no permanent strain that remained even after stress was removed. In all three high temperature tests both the maximum and minimum strains drift higher and reach much greater levels than at room temperature. There are two things going on here. Some of the increase in maximum strain is due to the decrease in composite modulus demonstrated in Figures 4-32 and 4-33. As the composite becomes less stiff the maximum strain increases. In addition, there is a permanent strain causing

Figure 4-34 Strain accumulation during 70% stress level fatigue test at 1200°C

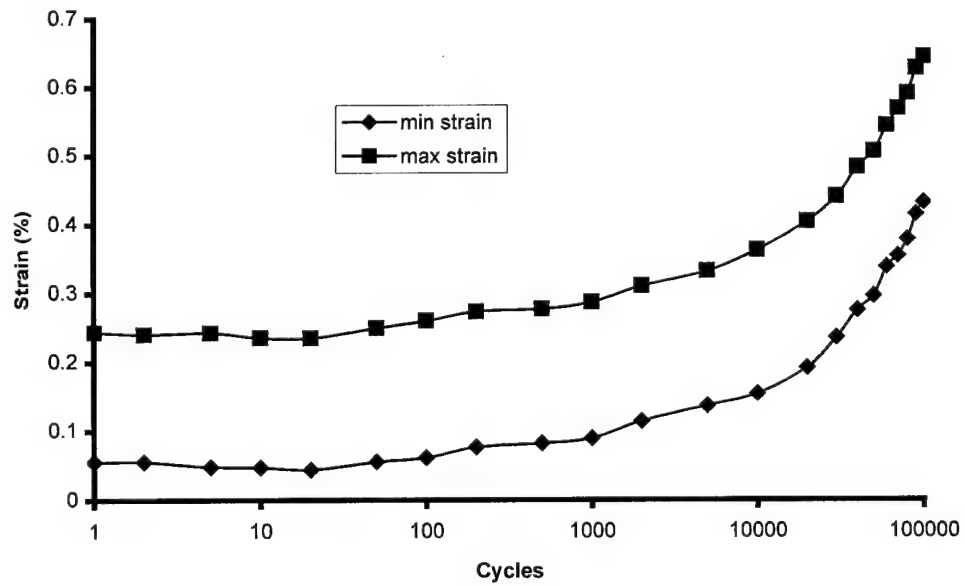
Figure 4-35 Strain accumulation during 80% stress level fatigue test at 1200°C

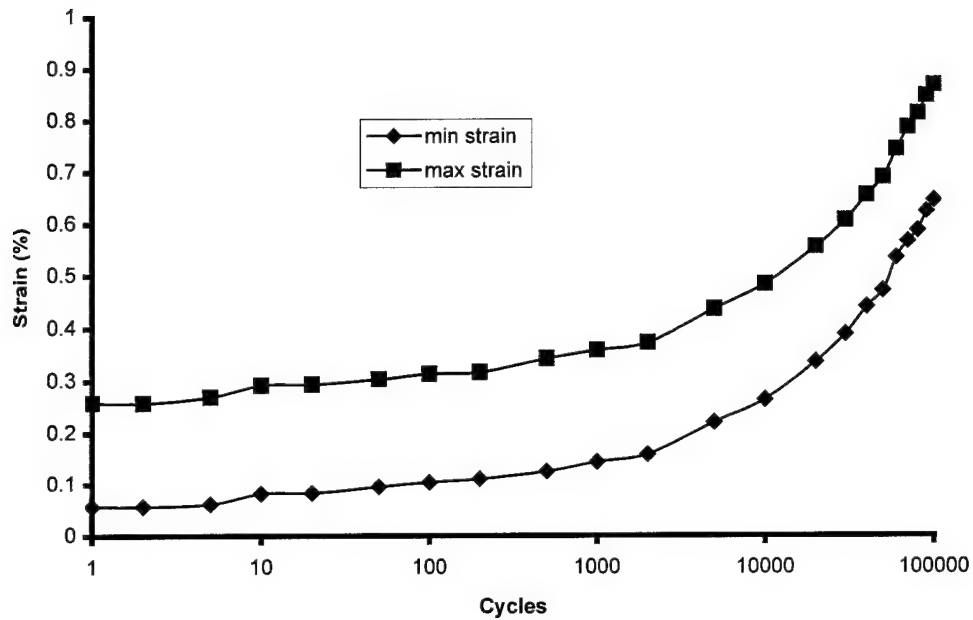
Figure 4-36 Strain accumulation during 90% stress level fatigue test at 1200°C

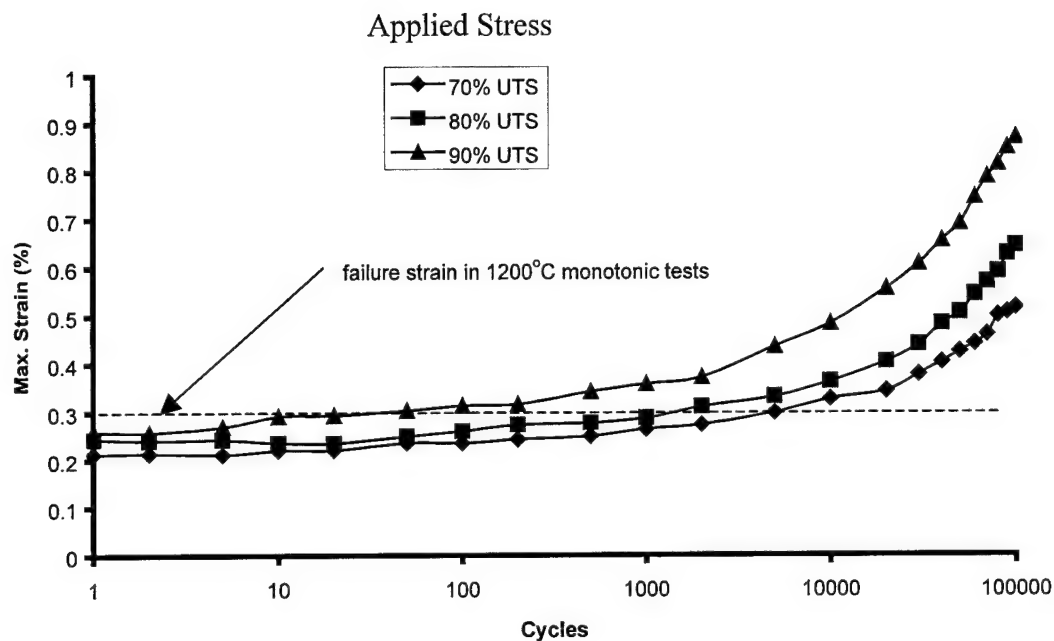
Figure 4-37 shows the maximum strains from all three tests plotted on the same graph.

Figure 4-37 Maximum strain progression in 1200°C fatigue tests

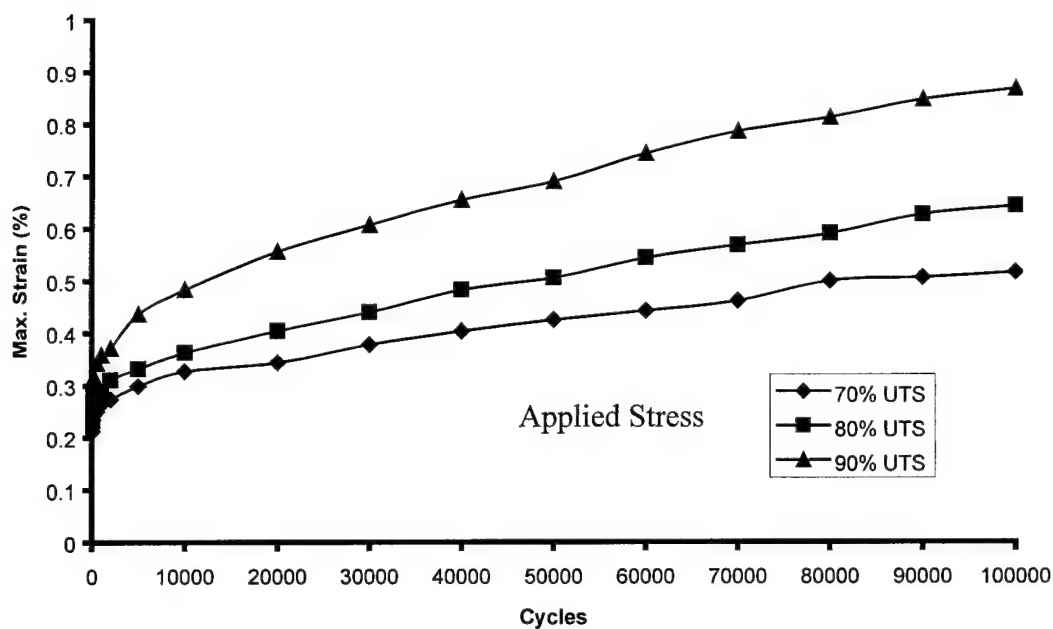
Figure 4-38 Maximum strain in 1200°C fatigue tests plotted on linear scale

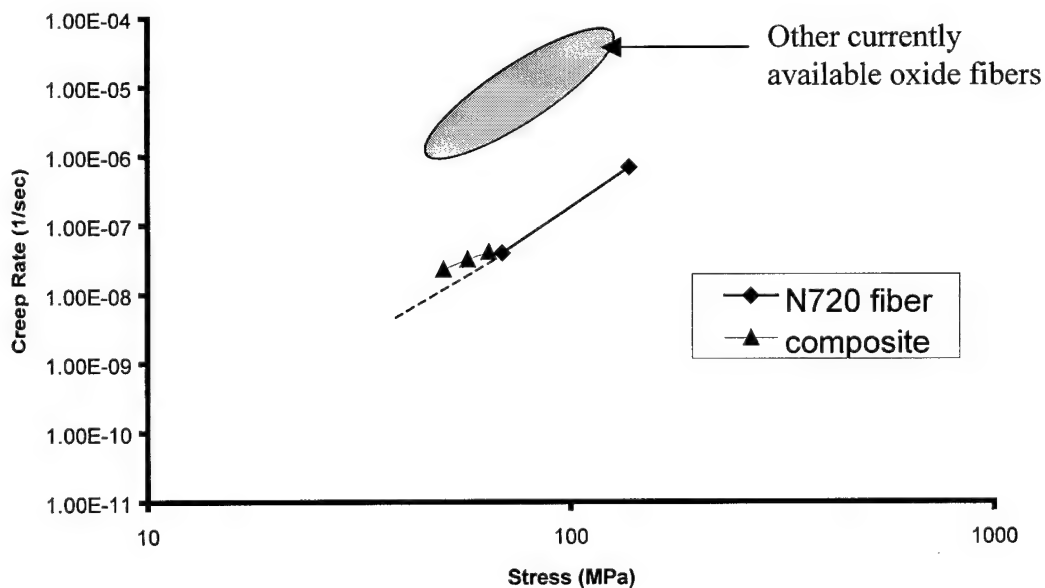
Figure 4-39 Steady state creep rates for N720 fiber (41) and N720/A composite at 1200°C

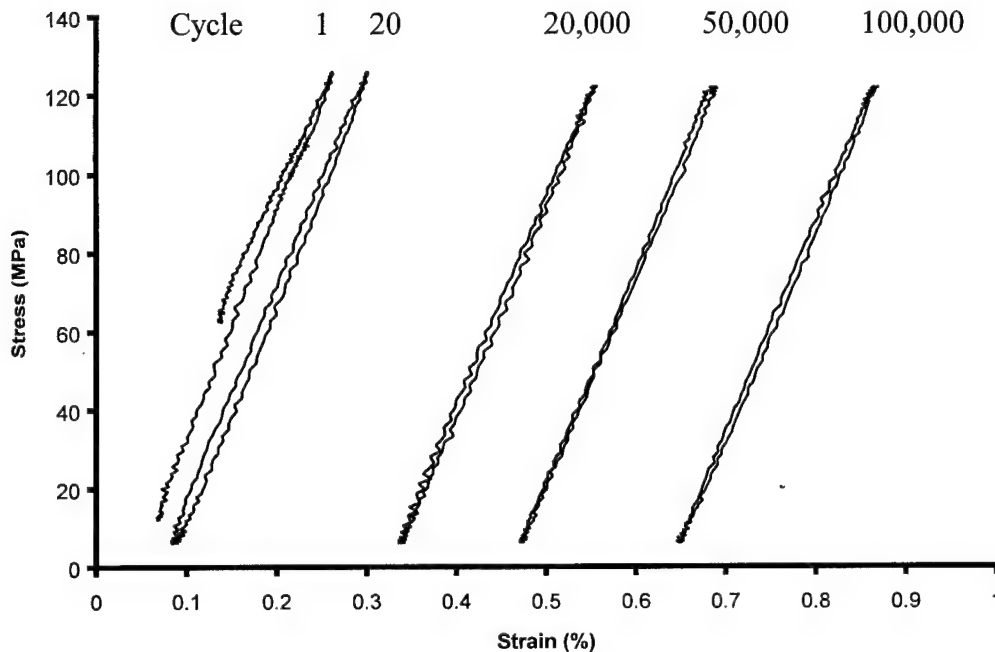
For further insight into fatigue behavior, stress-strain loops are examined next. Stress-strain loops are plotted for the 90% stress level test in Figure 4-40.

Figure 4-40 Hysteresis loops at 1200°C, 90% stress level

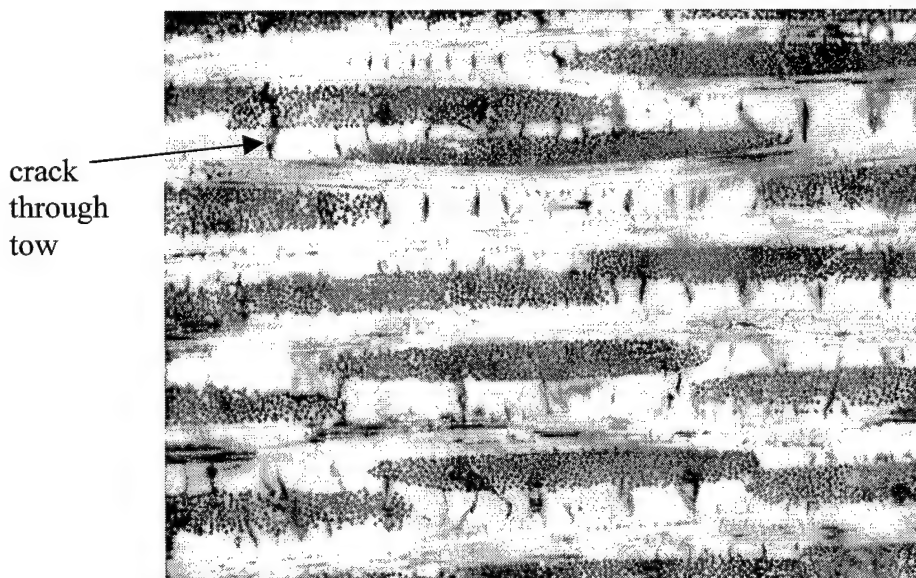
Figure 4-41 Possible fatigue damage, 50X

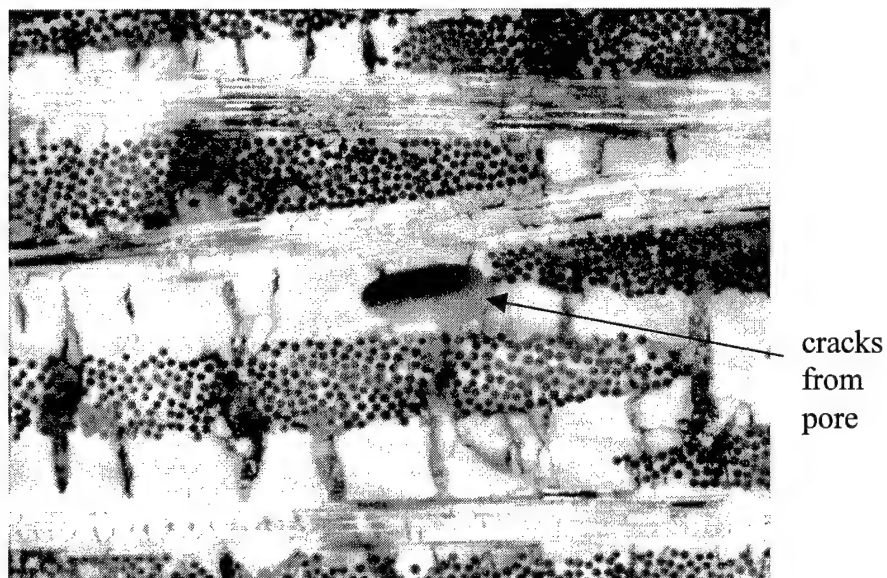
Figure 4-42 Possible fatigue damage, 100X

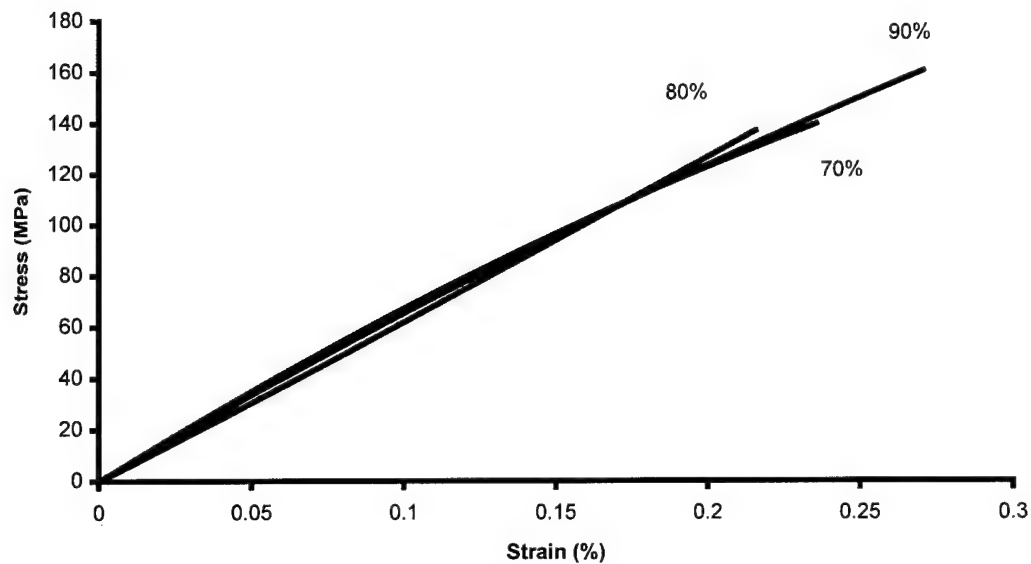
Figure 4-43 Stress-strain curves for 1200°C fatigue run-out specimens

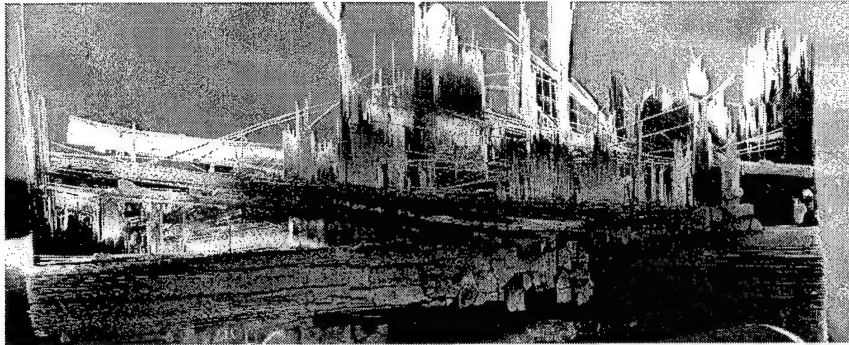
**Figure 4-44 Fracture surface of 1200°C fatigue specimen
after retained strength test, 20X**

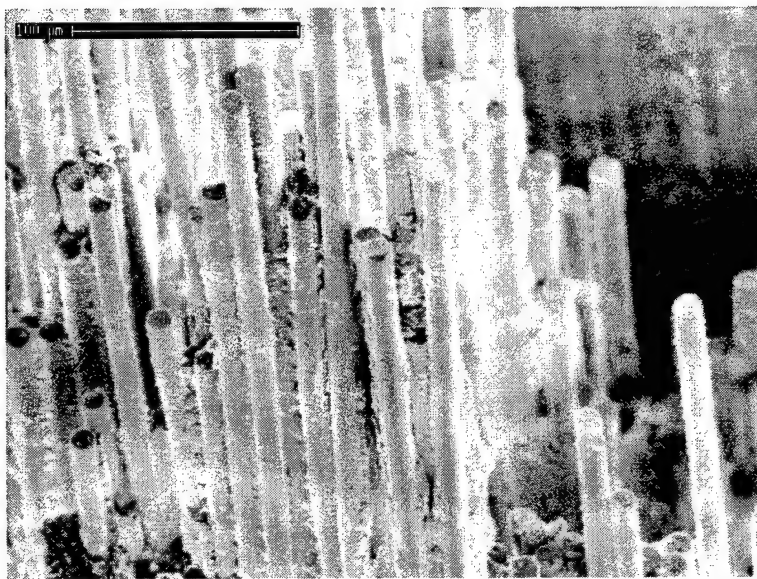
**Figure 4-45 Fracture surface of 1200°C fatigue specimen after
retained strength test, 360X**

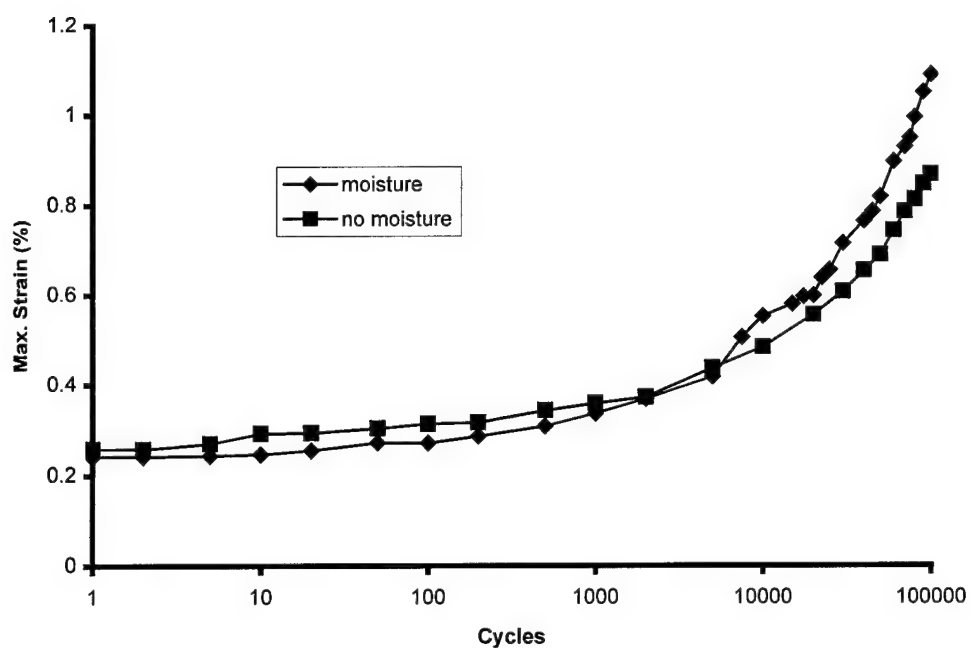
Figure 4-46 Maximum strain comparison, 1200°C fatigue, 90% stress level

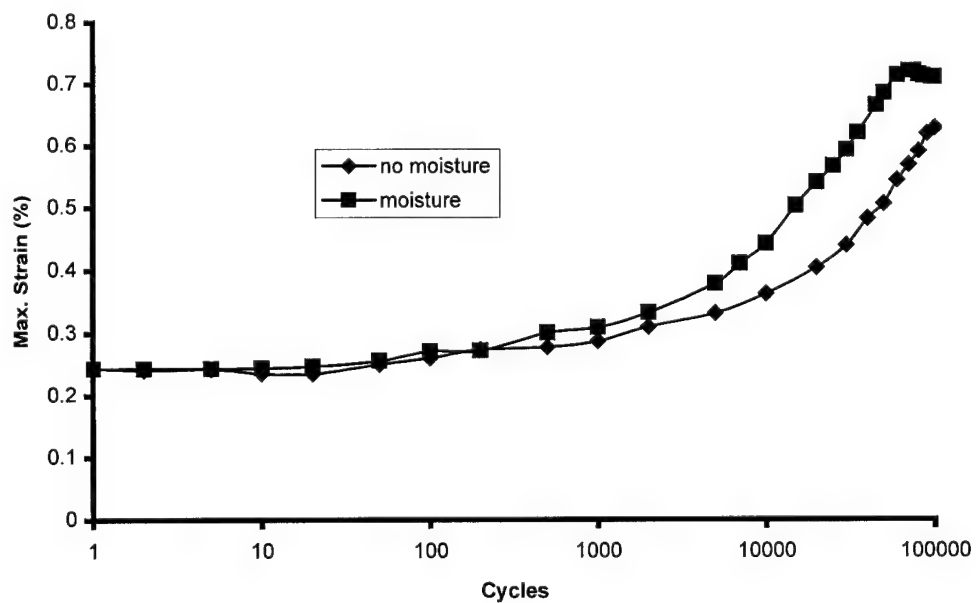
Figure 4-47 Maximum strain comparison, 1200°C fatigue, 80% stress level

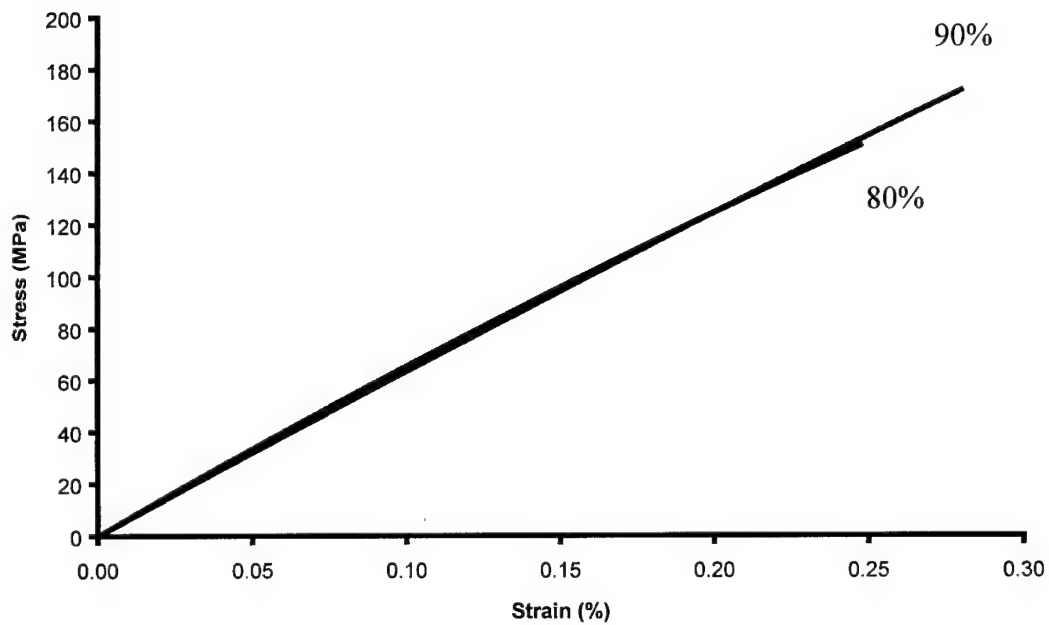
Figure 4-48 Stress-strain curves for retained strength tests

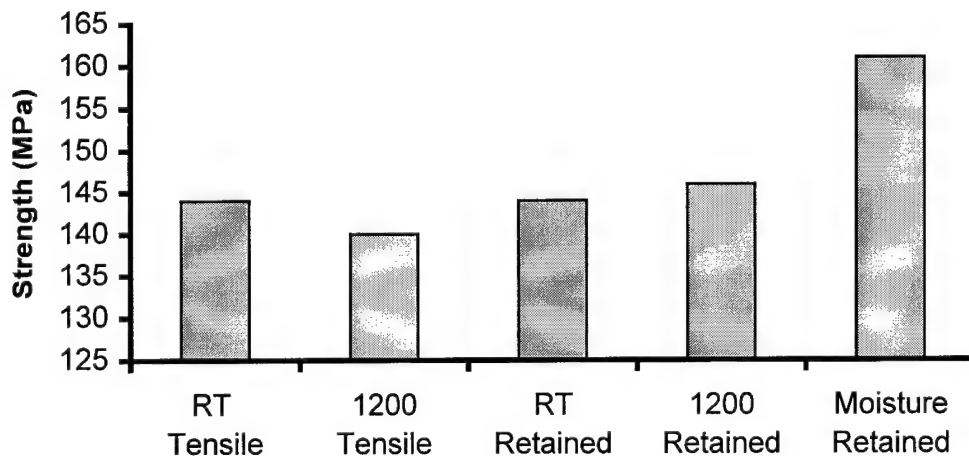
Figure 4-49 Retained strength compared to original strength

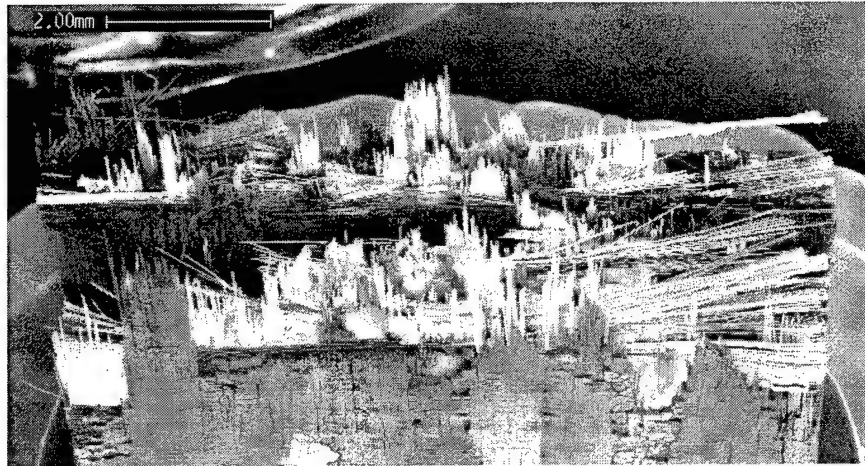
Figure 4-50 Fracture surface of 1200°C fatigue with moisture exposure after retained strength test, 10X

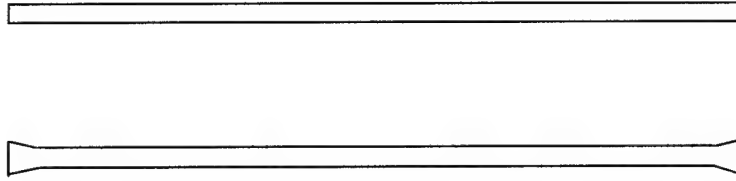
Figure A-1 Ideal specimen shape (top) vs. actual shape (bottom)
